**Archaeological Impact Assessment
for a proposed public realm
development at
Murgasty townland, (known as
Tipperary Hills), Tipperary, Co.
Tipperary.**

Report Author: F. Coyne MA HDip MIAI
Client: Dave Ryan Landscape Architects,
12 Barrington St,
Limerick.
Report Status: Final
Date: 14 February 2023

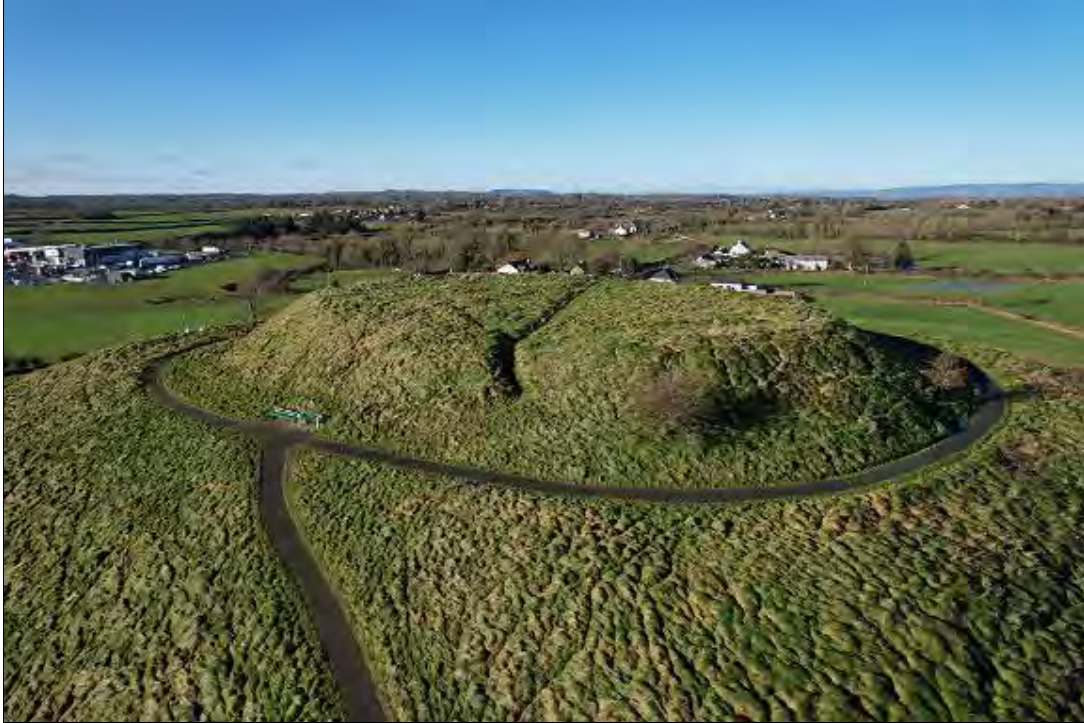
The several winding tarmac pathways traverse the parkland, with a path encircling the motte. Pedestrian traffic onto the top of the mott has cut a deep groove into the southern side of the face of the motte. This is approximately 0.5m deep at its deepest. Several deep grooves have been cut into the top of the motte also by pedestrian footfall.

Plate 1. Motte TS067-002--- from S. Note groove caused by pedestrian traffic.

The motte is currently being accessed by many visitors to the park, using a steep access track on the southern face of the monument. There are signs of erosion on this route to the top of the Motte. To prevent further erosion caused by pedestrians, a floating stairs and hand rail construction is propose (see figure 14 below), where the construction has minimal impact on the ground itself. Several posts will have to be driven into the ground in order to lift the path up from it. Then beams are placed over the posts where the boarding and rail can be attached. The construction of the set of stairs would consist of two flights and one landing, and follow the line of existing ground levels and contours. The stairs would conform to building regulation standards, and be constructed of timber or a composite timber material to reduce maintenance.

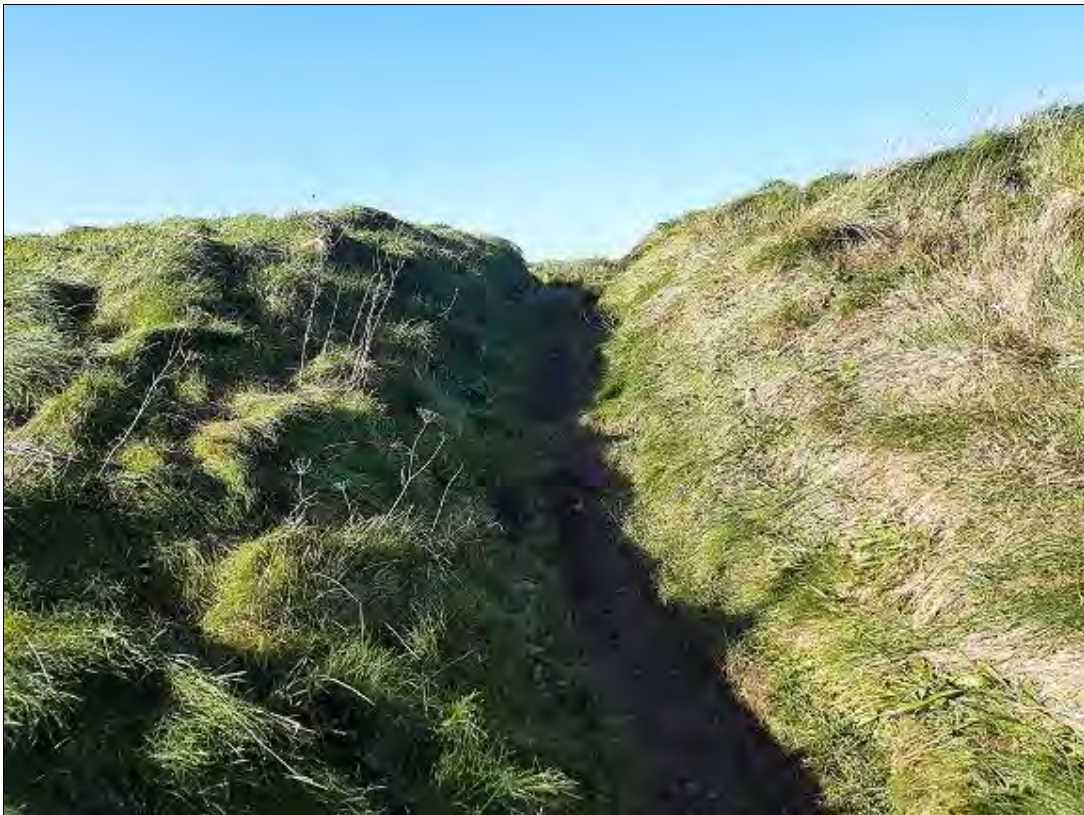
Plate 2. Detail of deep groove caused by pedestrian footfall on S face of motte, from S.

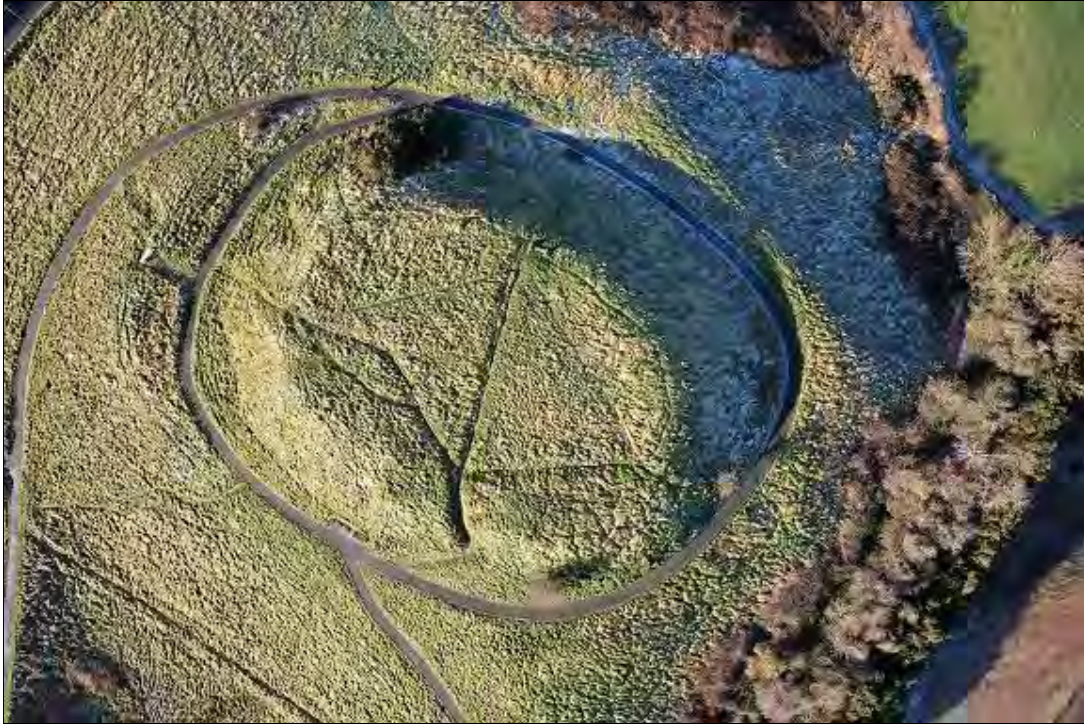
Plate 3. Aerial view of motte. Note grooves/paths caused by pedestrian footfall.

Prolonged pedestrian access to the top of the motte has led to the erosion of the top of the motte. In order to give access and reduce further erosion on top of the motte a Ballylusk gravel path without kerb is proposed. This will provide a formal circular route on the top of the mount, the Ballylusk will suppress the grass and will make it less likely that people cross diagonally over the Motte.

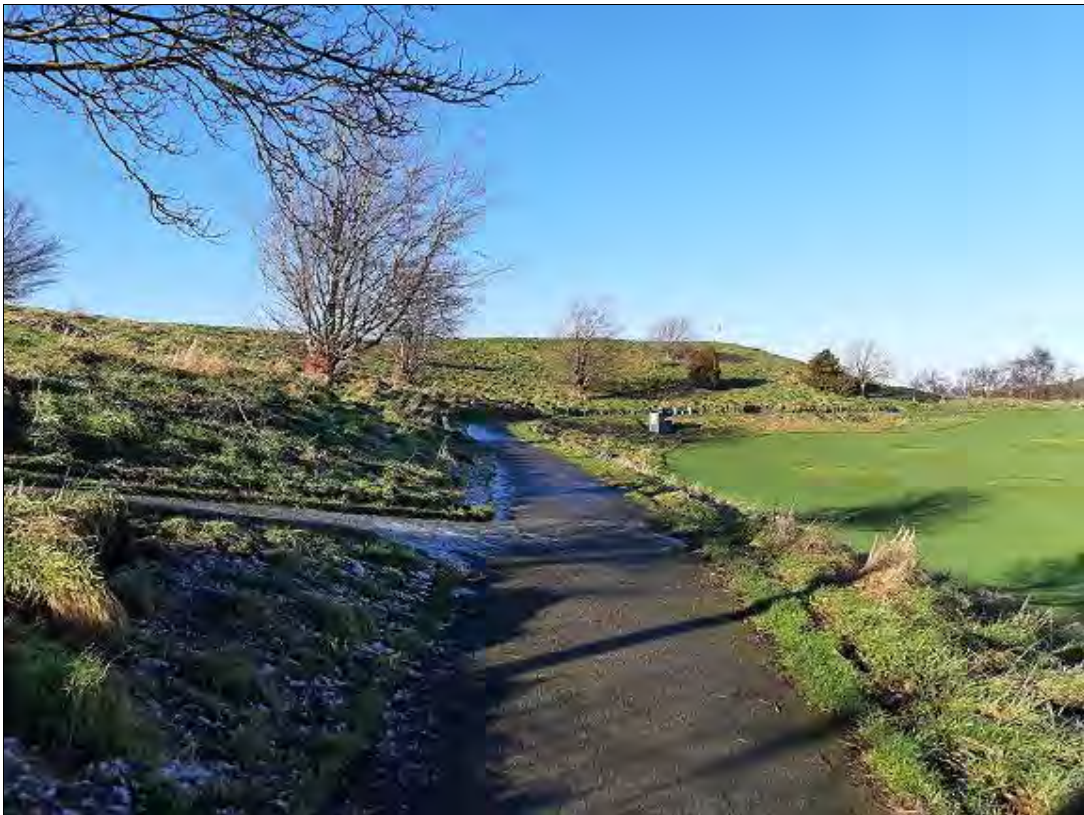
Plate 4. Examples of existing paths at E side of site, from S.

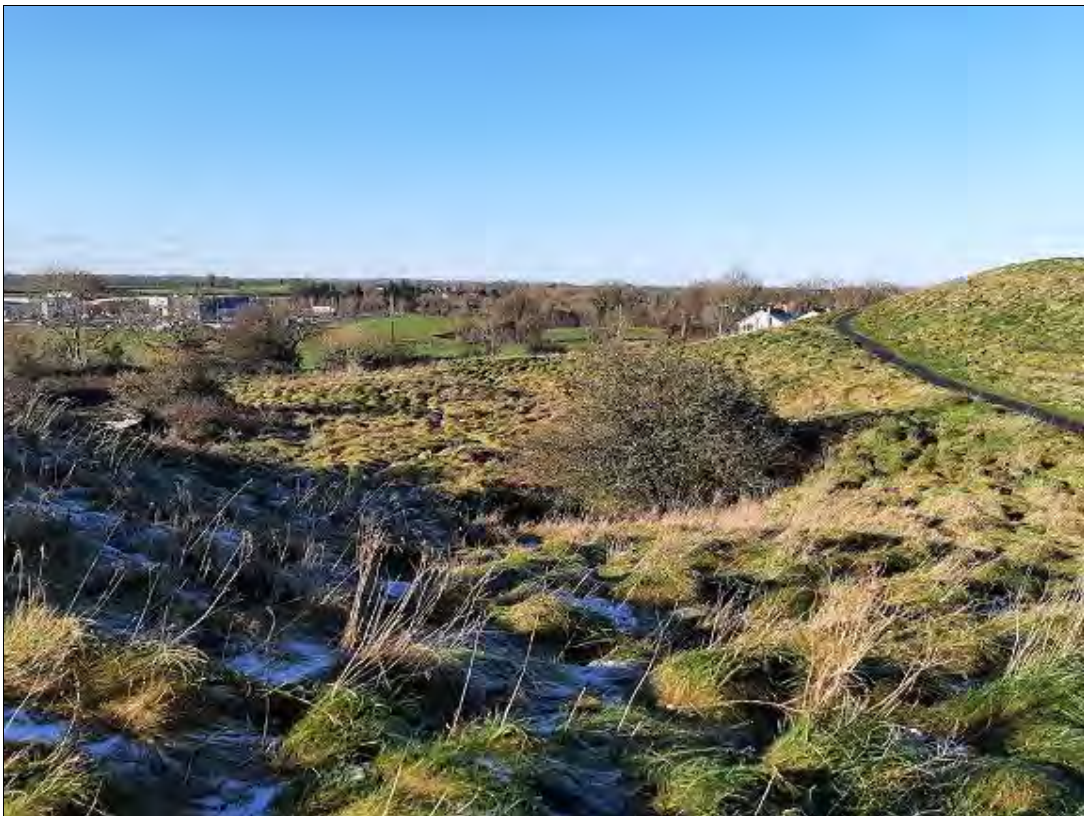
Plate 6. Proposed location of dog park, from SE.

The majority of the proposed works involve planting, woodland and native wildflower meadows, as well as upgrading of existing pathways. A kickabout area is proposed, which will involve minimal ground disturbance, as well as a dog park. This dog park will involve some ground disturbance.

However, it is located 40m to the south of the base of the natural hill on which the motte is located. Some works are proposed on the motte itself.

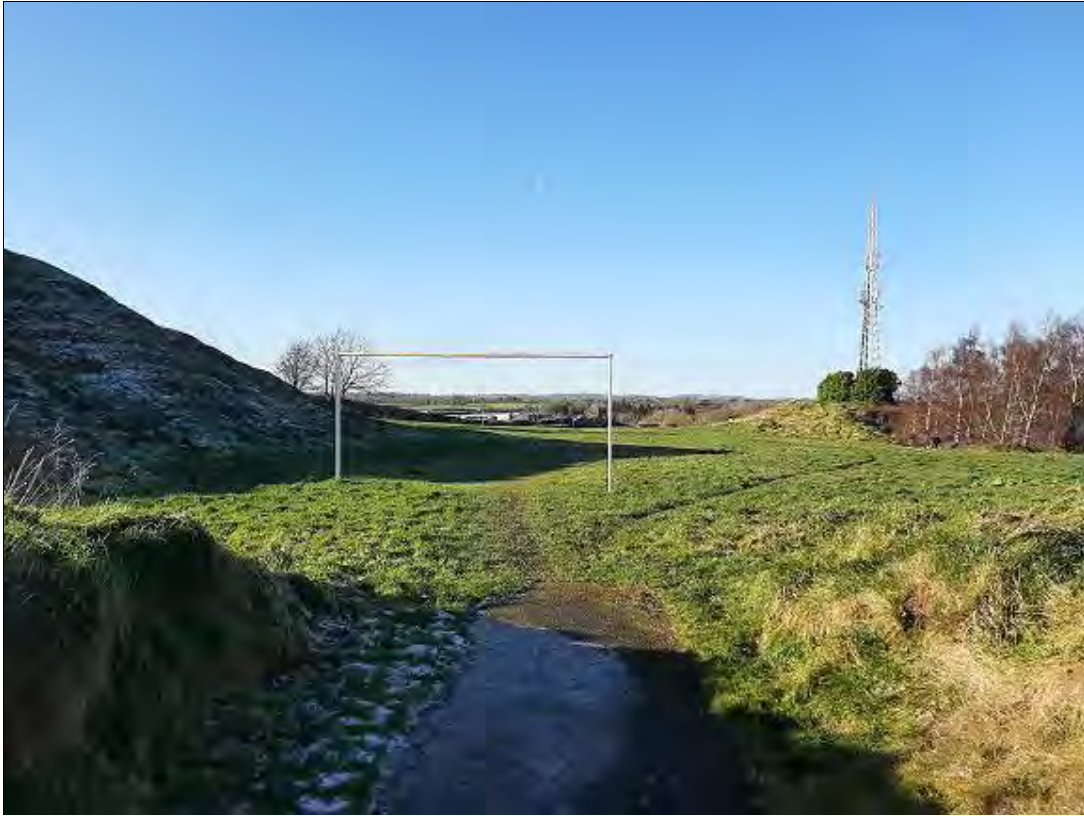
Plate 7. Proposed location of kickabout area, from E.

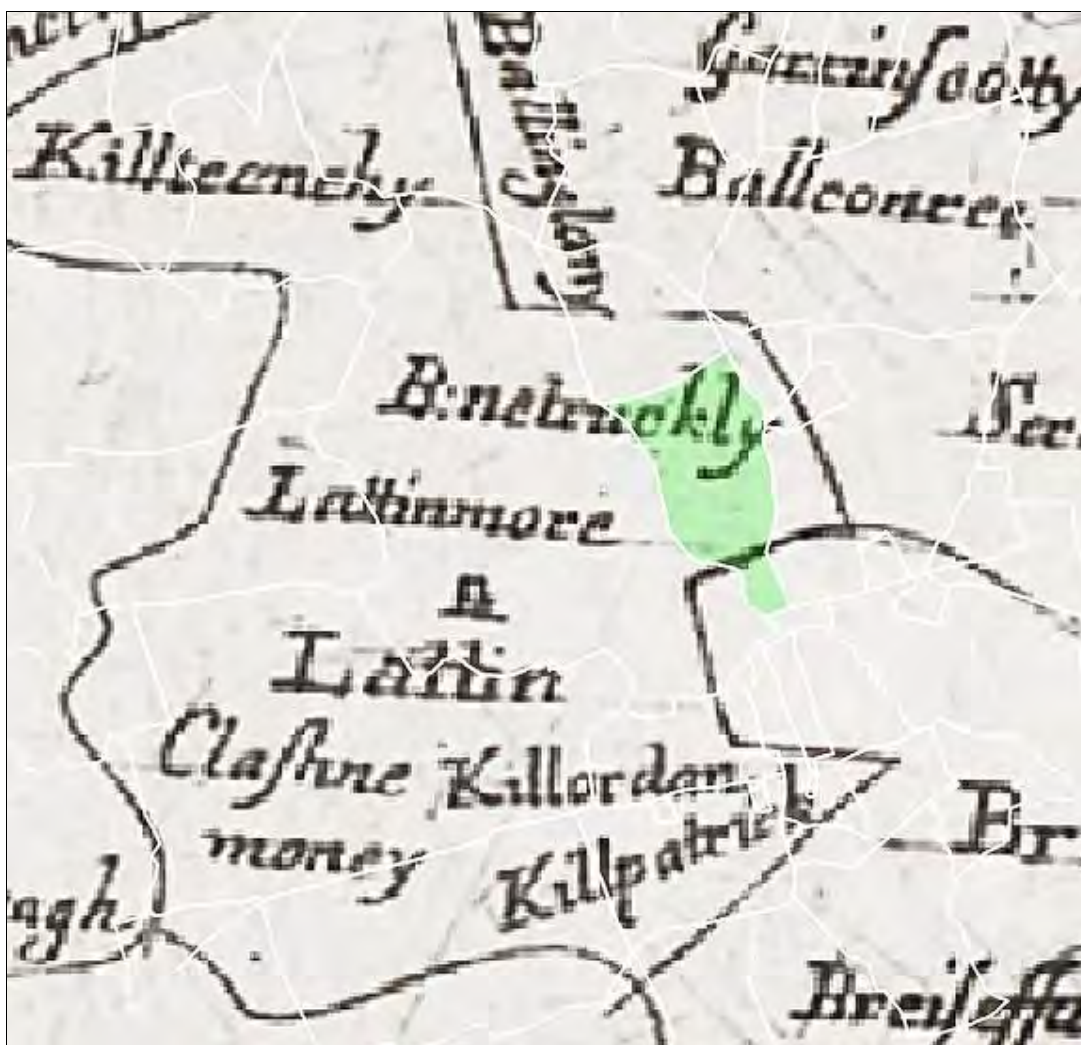
Figure 10. Extract of seventeenth-century Down Survey county mapping for Co. Tipperary; showing modern day townland of Murgasty (<http://downsurvey.tcd.ie/landowners>).

The seventeenth century Down Survey barony map was consulted for the subject site and did not show anything of interest in the location of the subject site. In 1641 the owner of the townland of Murgasty is listed as the Daniell Ryan (Protestant), with the owner in 1670 listed as Erasmus Smith (Protestant). The 1659 census records a total of 72 inhabitants, of which 55 were English and 17 were Irish. The profitable land is listed as 31 plantation acres (<https://downsurvey.tchpc.tcd.ie/landowners.php#mc=52.486123,-8.175867&z=14>).
